ENGINEERING PROJECTS:PROGRESS REPORT

Hurricane Matthew Recovery Project

Cross Creek Bank Stabilization at Lamon Street

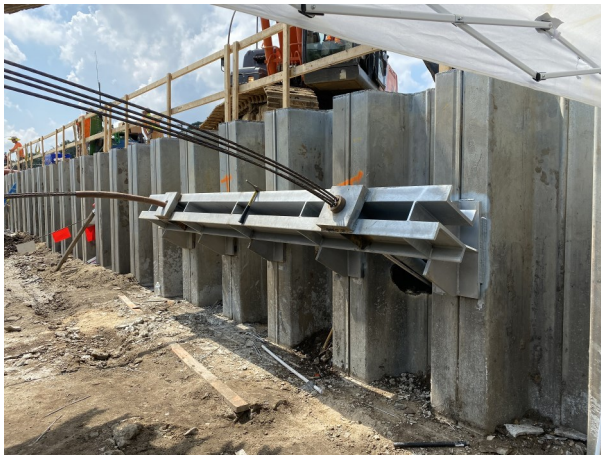
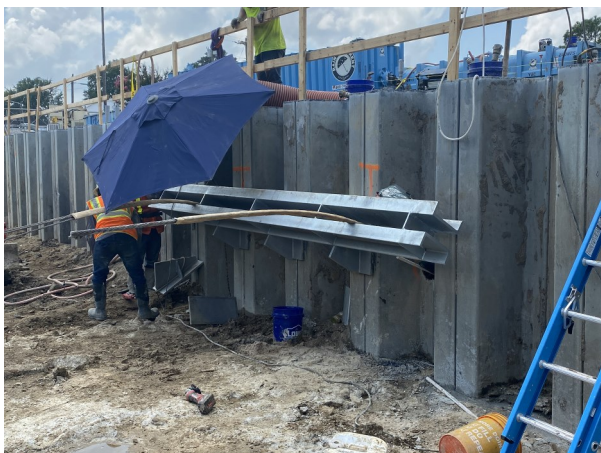
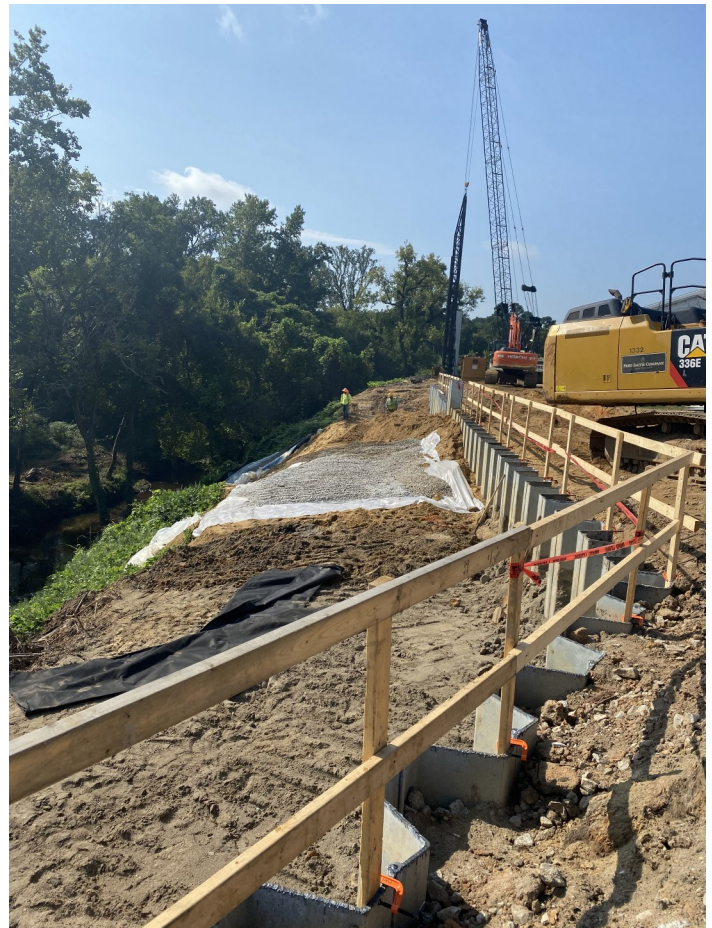
This week the contractor completed driving piles and continued cutting sheet piles to specified height. They continued excavating earth in efforts to support tie back operations. The contractor also installed and tested five cables and two whalers
